## Stair Installation Top Tip

### The Problem

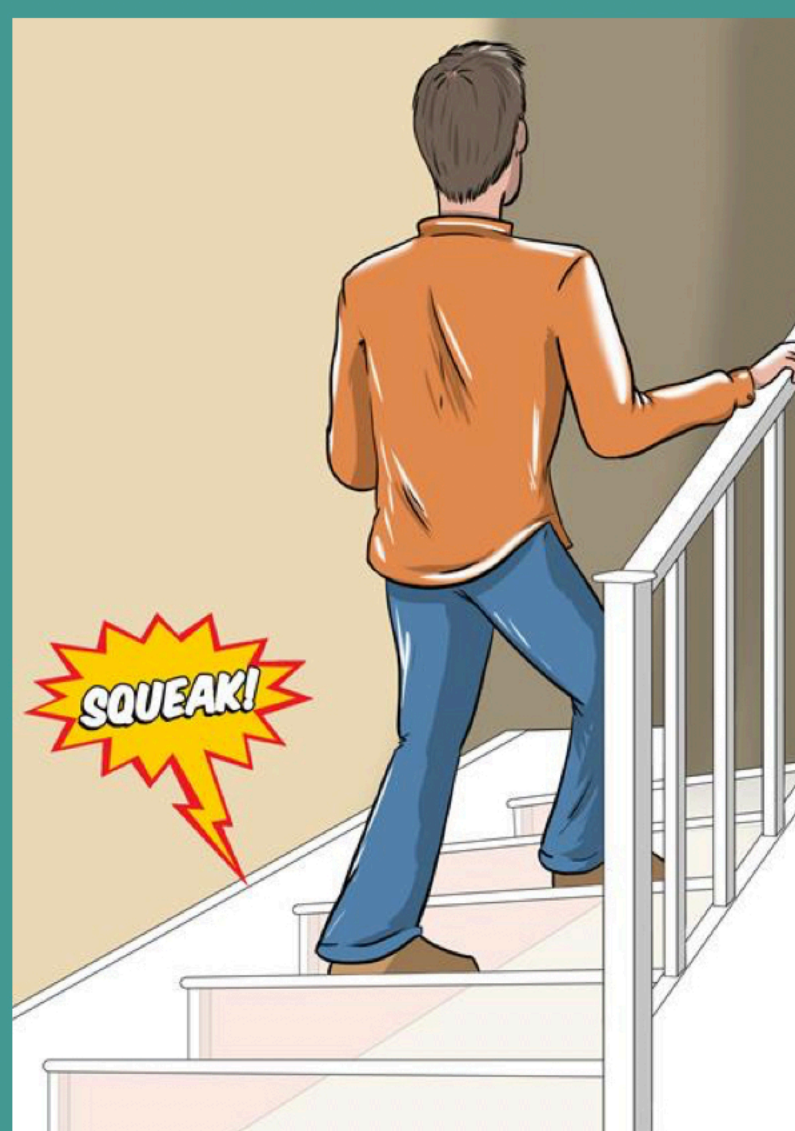
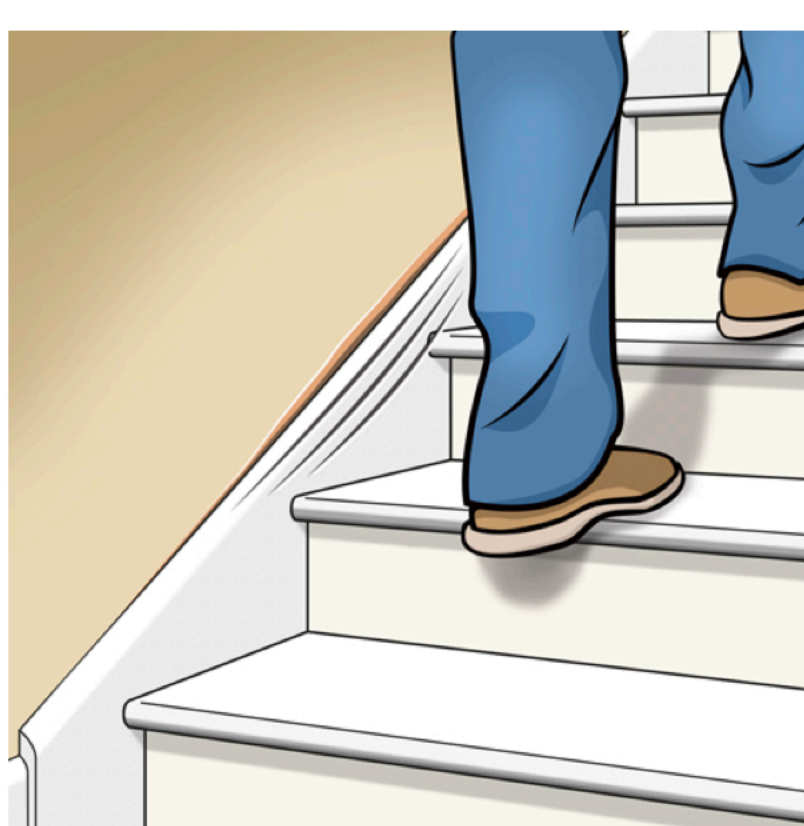
Stairs are likely to squeak when there is movement between the stair string and the adjacent plasterboard or timber packer.

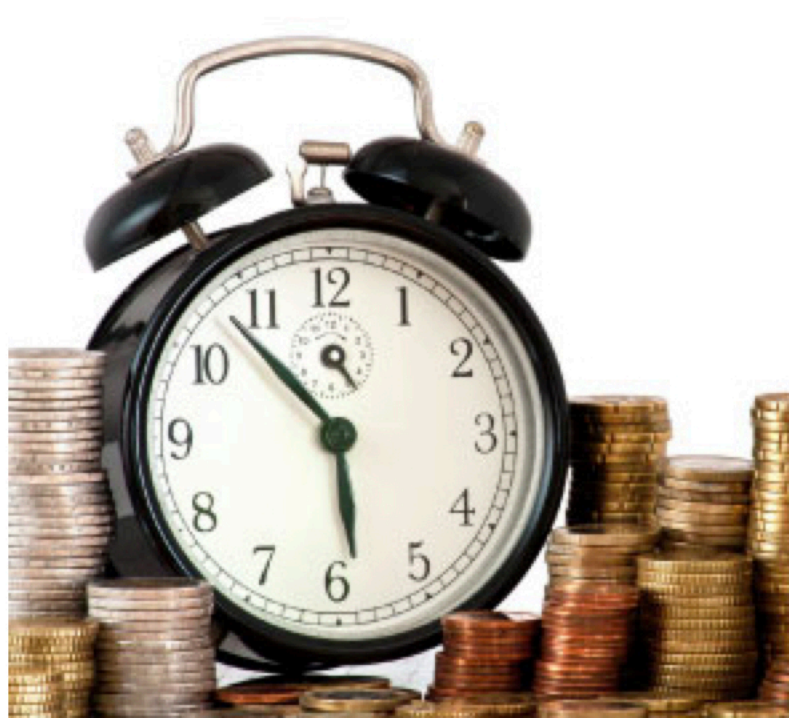
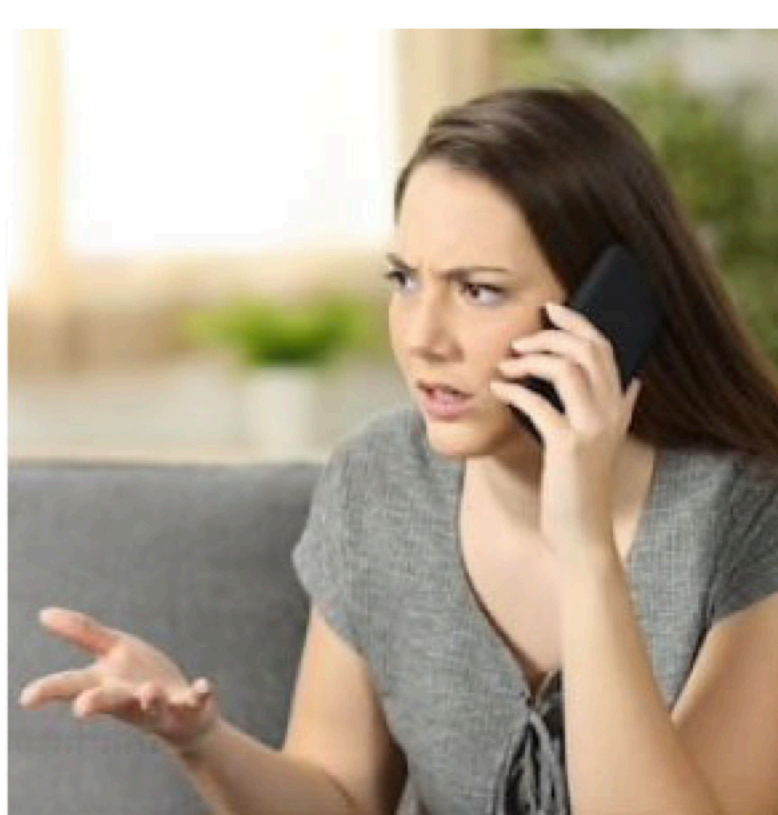
The problem is the result of the stairs not being properly fixed to the adjacent supporting walls.

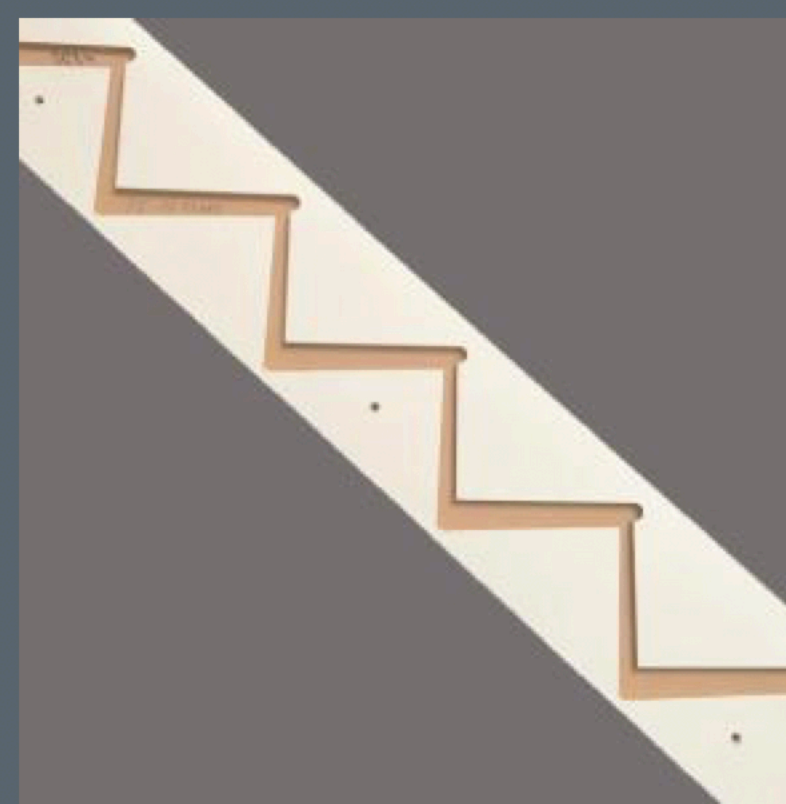
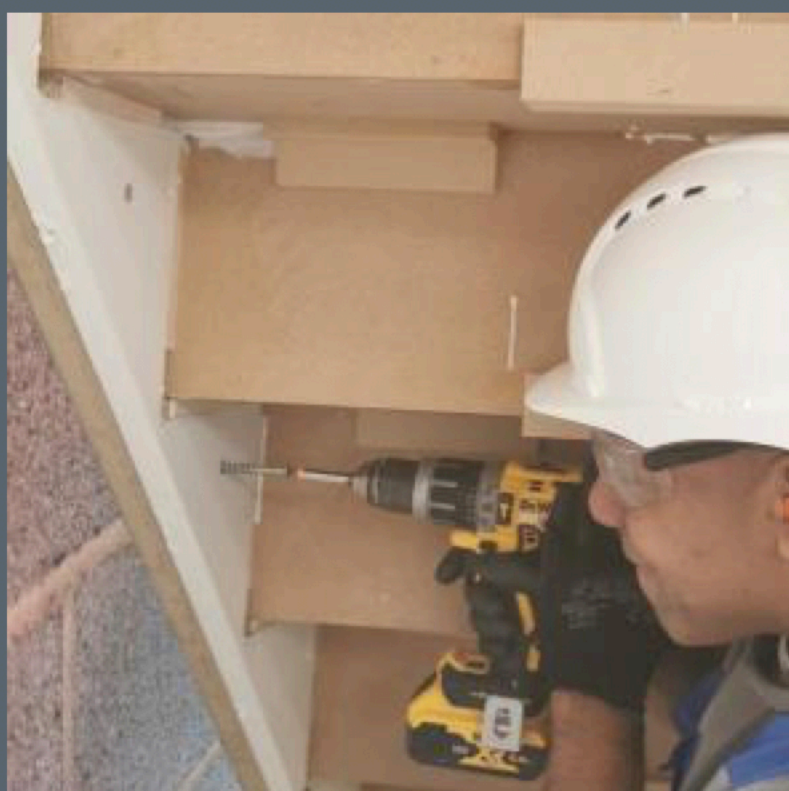
Following extensive testing and software development we are the only stair manufacturer able to pre-drill optimised fixing points specifically relating to the flight supplied.

These fixing points highlight where stairs should be fixed and allow simple on-site quality checks during the build process to diminish the risk of squeaking stairs and potential customer care issues post occupancy.
