Stair Installation Top Tip

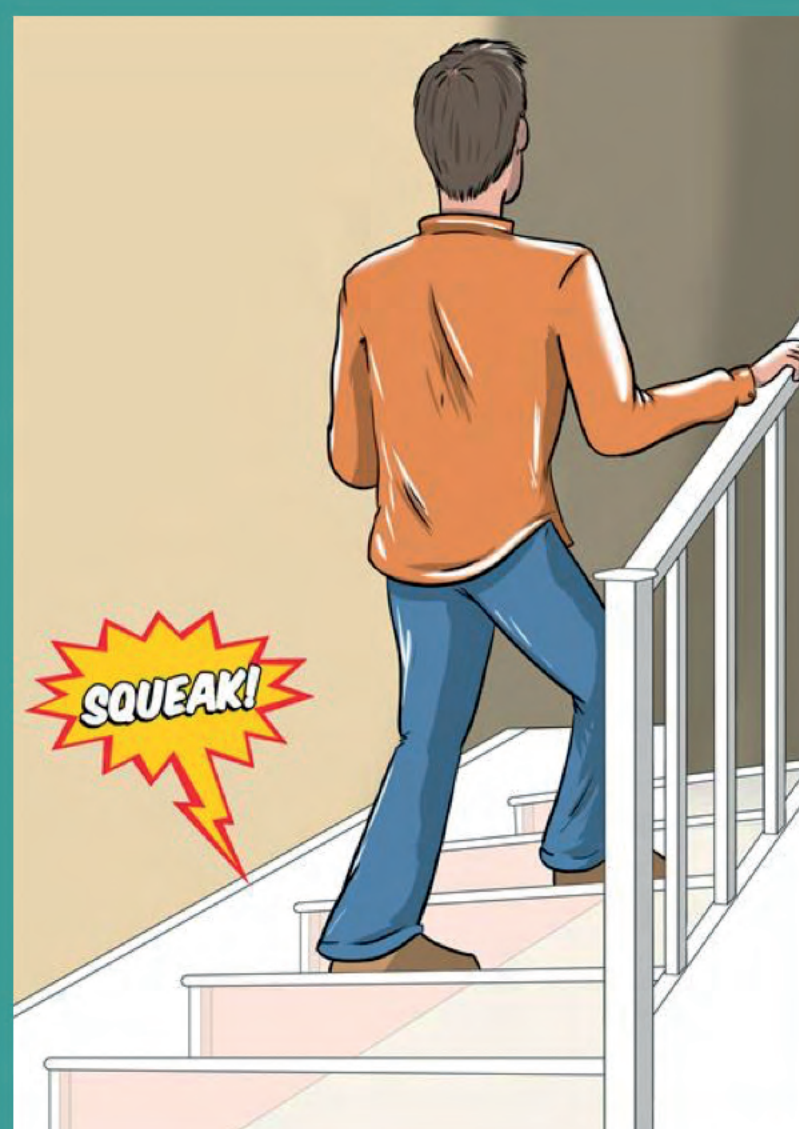
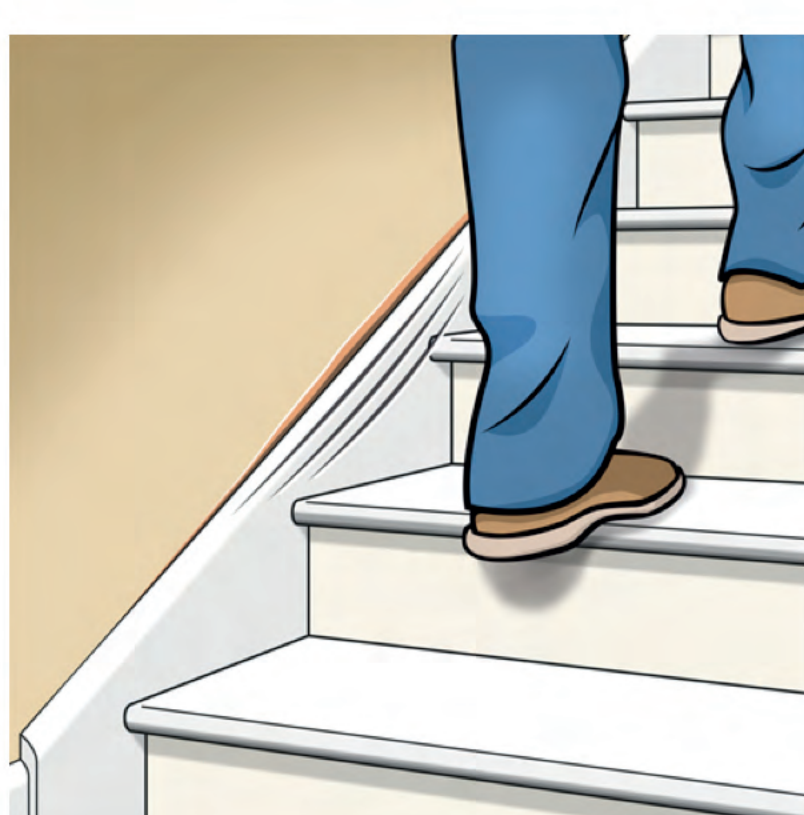
Stairs are likely to squeak when there is movement between the stair string and the adjacent plasterboard or timber packer.

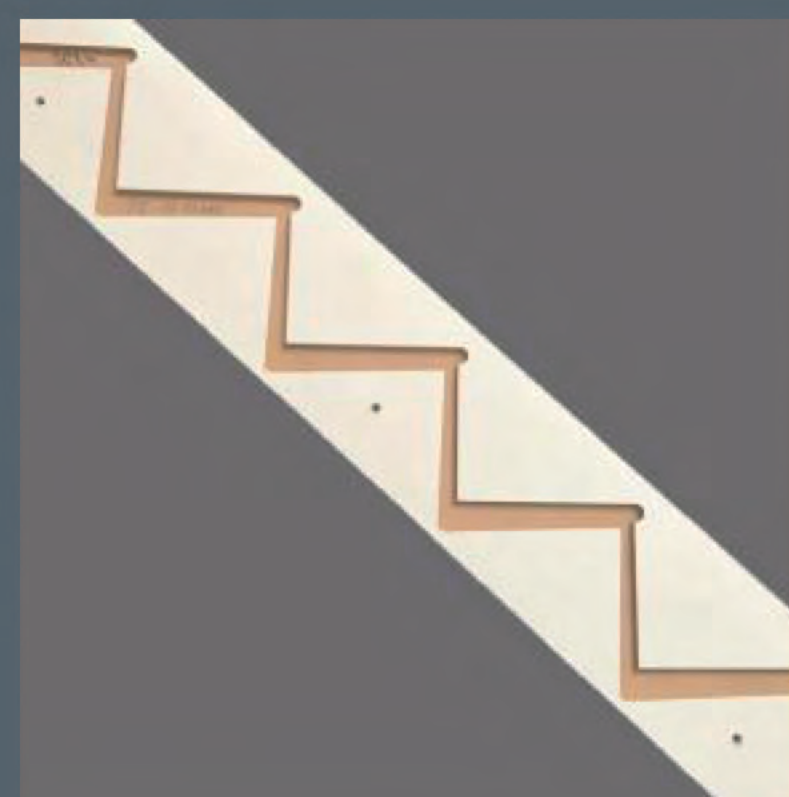
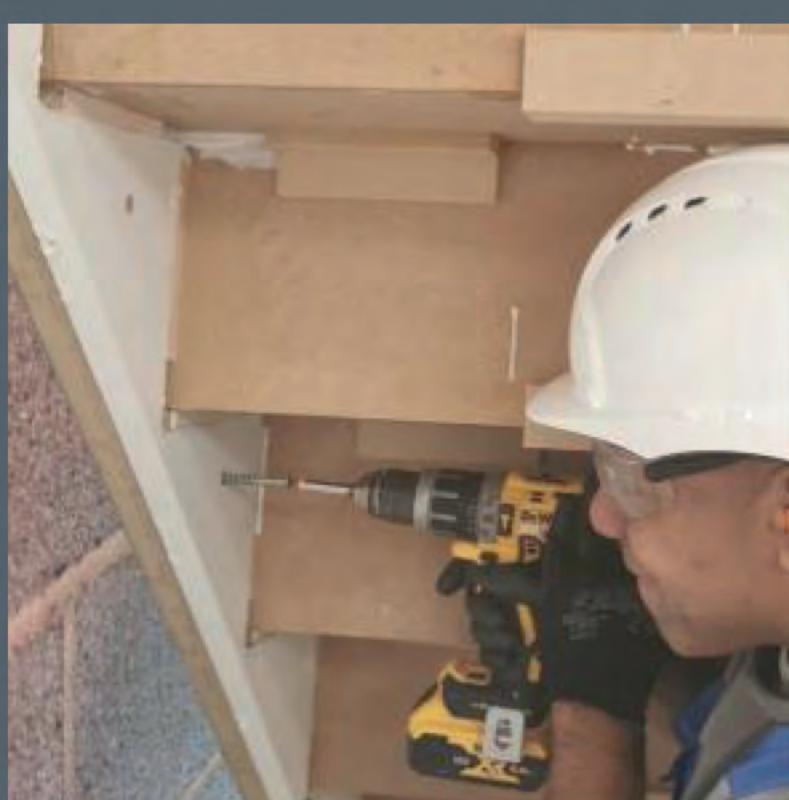
Following extensive testing and software development we are the only stair manufacturer able to pre-drill optimised fixing points specifically relating to the flight supplied.

These fixing points highlight where stairs should be fixed and allow simple on-site quality checks during the build process to diminish the risk of squeaking stairs and potential customer care issues post occupancy.
