Guidance To Keep Your Site Teams & Sub-Contractors Safe

Following a recent stair collapse we felt obliged to share the findings in order to prevent a repeat of this type of incident. In summary the stair collapse occurred due to an incomplete assembly and incorrect installation: -

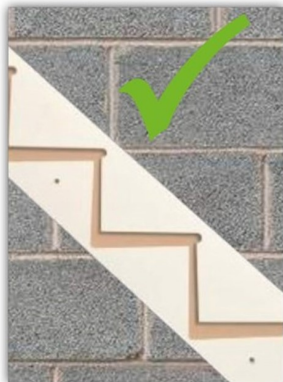
- ✗ Flight was lifted into position only part assembled
- ✗ Contractor did not fix glue blocks and wedges to the winder section
- ✗ Stair was fixed with only 3 fixings into plasterboard - so no structural viability or support
- ✗ Stair was not braced at the bottom to stop slippage
- ✗ Operatives scaled the flight prior to fixing into position

DO NOT CLIMB STAIRS UNTIL FULLY FIXED IN POSITION

The contractor has taken full responsibility and we are pleased to report serious injury was avoided. The risks of improper fixing should not be underestimated..
