# STAIRCRAFT<sup>®</sup> Group

## Important Stair Specification Improvements

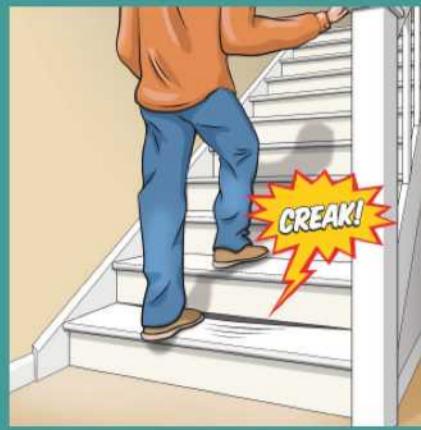
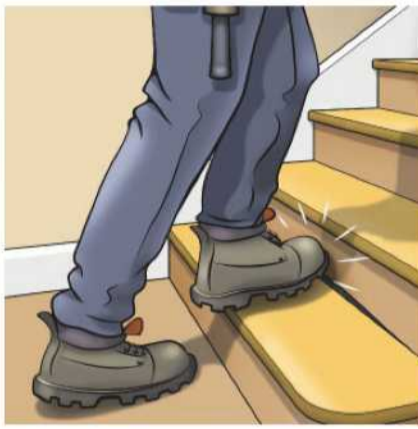
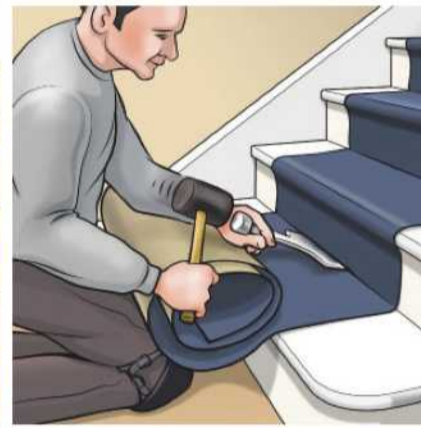
### The Problem

Squeaky stair treads or treads feeling 'spongy' underfoot.

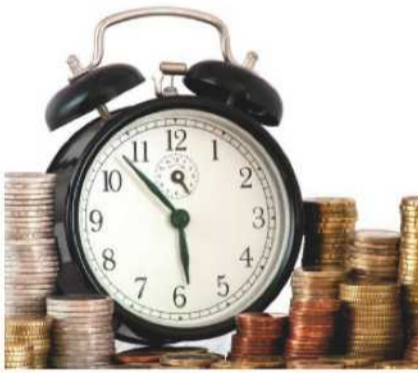
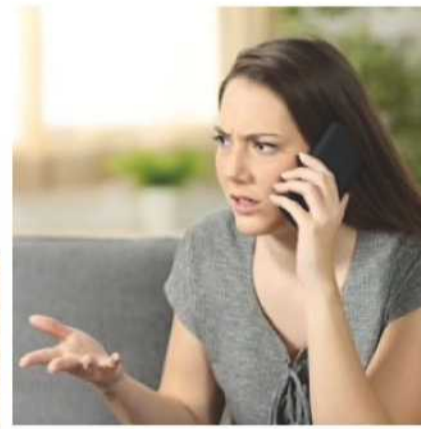
Both problems are the result of stair tread/riser joints becoming loose or detached during the construction process – either by risers being **kicked by safety boots** during the build process or **over zealous use of a bolster** when fitting carpets/gripper rods.

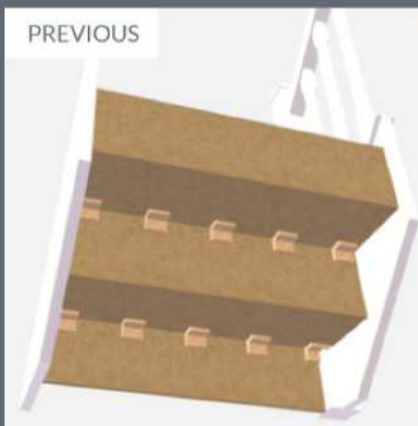
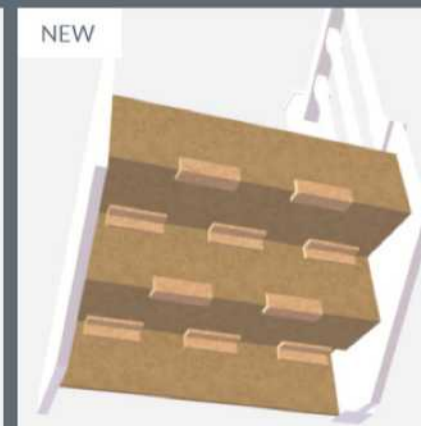
We have a **3x stronger connection** in the tread/riser joint to help reduce your call backs, as we cannot control how our Stairs are stored and installed on site. As you would expect, our connection strength was already comfortably out-performing that demanded by British Standards.
