# STAIRCRAFT® Group

## Important Stair Specification Improvements

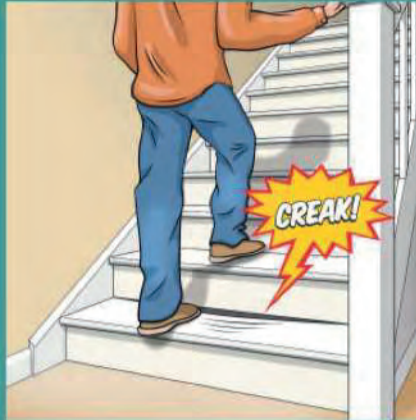
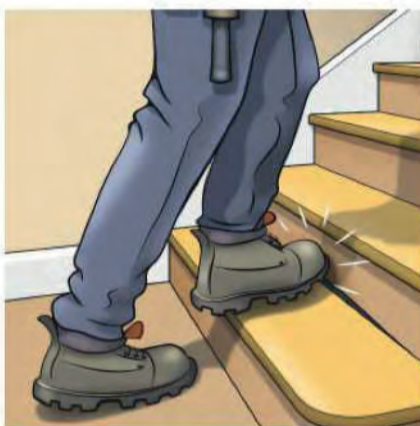
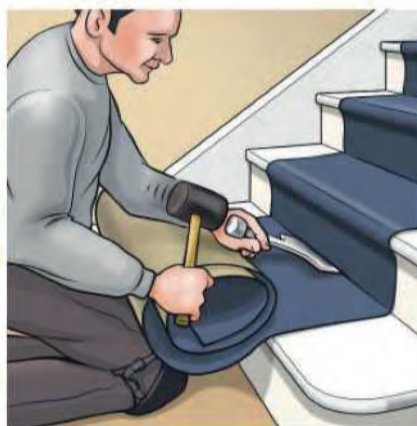
Squeaky stair treads or treads feeling 'spongy' underfoot.

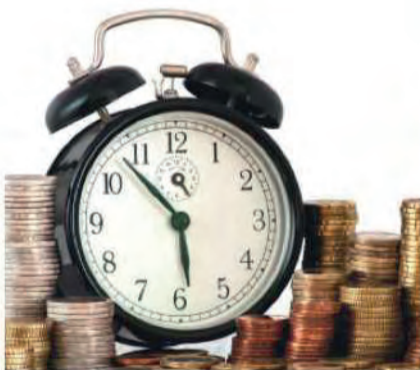
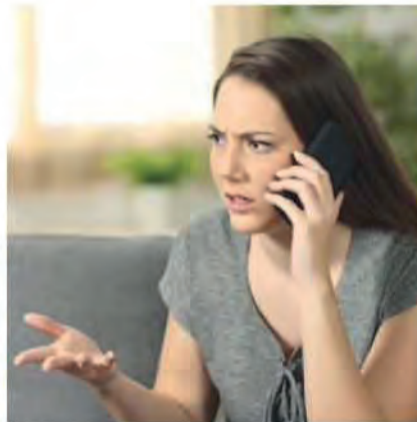
Both problems are the result of stair tread/riser joints becoming loose or detached during the construction process – either by risers being **kicked by safety boots** during the build process or **over zealous use of a bolster** when fitting carpets/gripper rods.

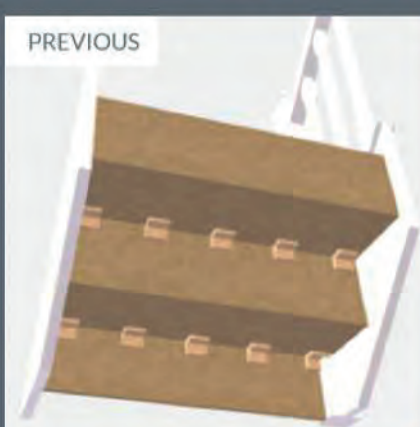
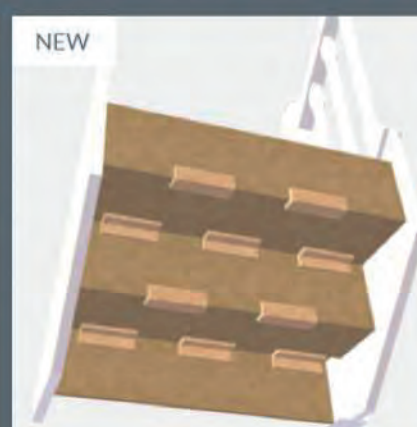
We have a **3x stronger connection in the tread/riser joint** to help reduce your call backs, as we cannot control how our Stairs are stored and installed on site. As you would expect, our connection strength was already comfortably out-performing that demanded by British Standards.
