STAIRCRAFT® Group

Important Stair Specification Improvements

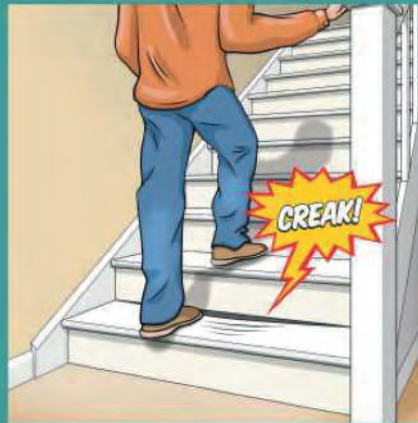
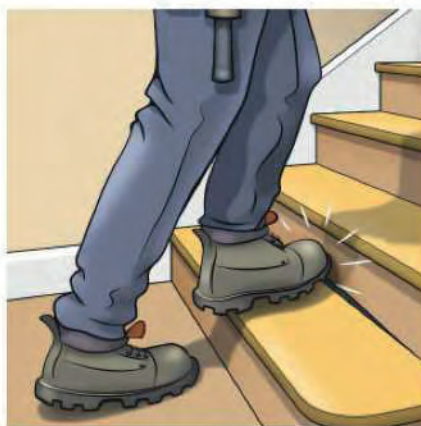
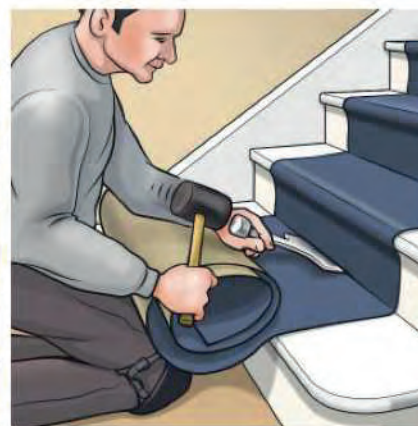
Squeaky stair treads or treads feeling 'spongy' underfoot.

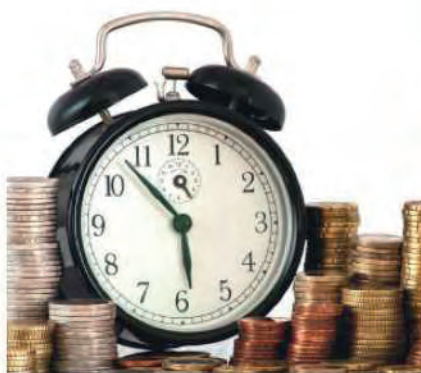
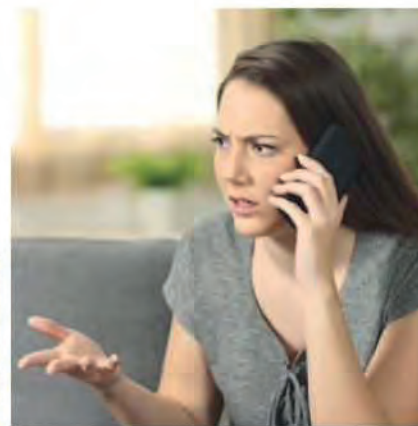
Both problems are the result of stair tread/riser joints becoming loose or detached during the construction process – either by risers being **kicked by safety boots** during the build process or **over zealous use of a bolster** when fitting carpets/gripper rods.

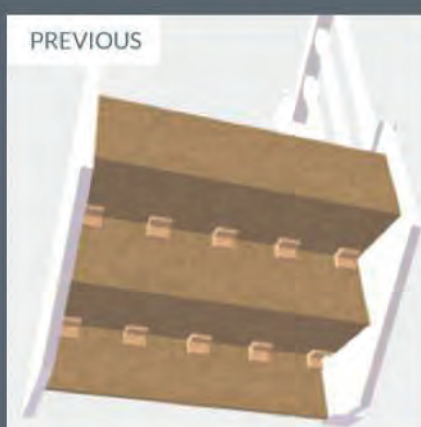
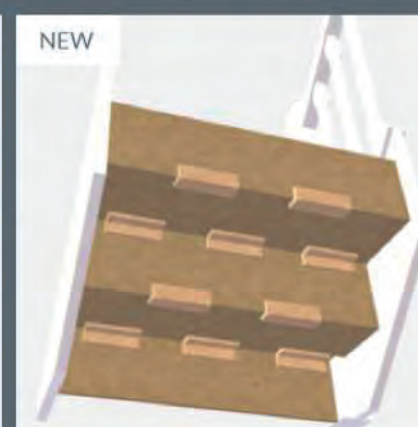
We have a **3x stronger connection in the tread/riser joint** to help reduce your call backs, as we cannot control how our Stairs are stored and installed on site. As you would expect, our connection strength was already comfortably out-performing that demanded by British Standards.
